SOUTHWESTER

The Southwest Chapter—Antique & Classic Boat Society newsletter serving Arkansas, New Mexico, Oklahoma, and Texas

December 2008

The Caddy-HACK!

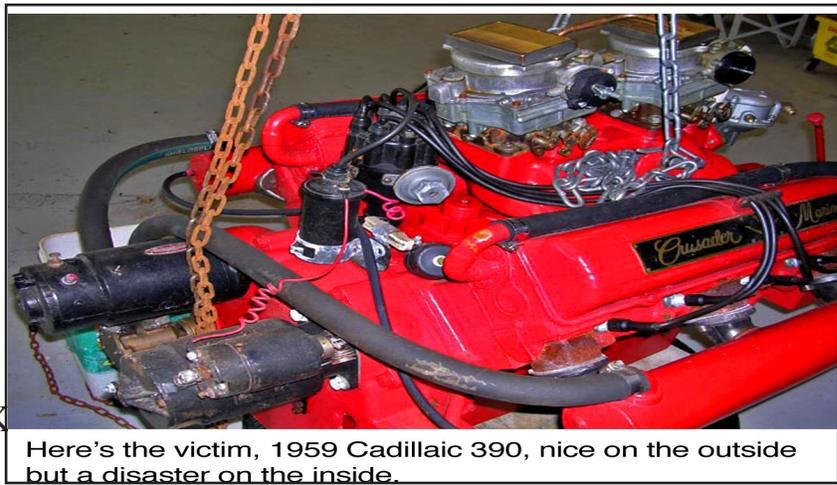
Here's the victim, 1959 Cadillac 390, nice on the outside but a disaster on the inside.

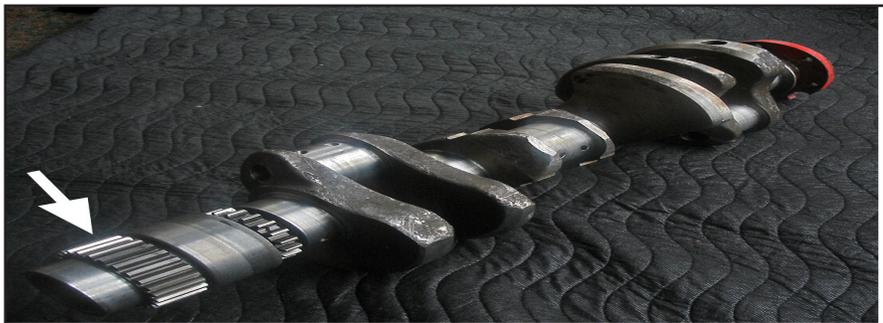
Here is the beast of a crankshaft out of the Caddy. That funny looking gear on the front of crank is the drive adaptor for the trasmission, this is opposite from a car which drives from the flywheel side.

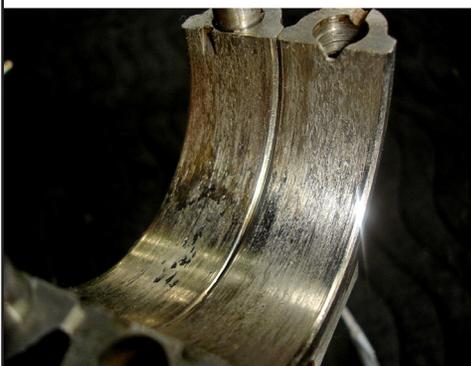
Upon removal from the boat and a subsequent draining of various engine fluids we bolted the old caddy to an engine stand and removed the oil pan. Quickly we found the #3 connecting rod flopping around on the crankshaft journal. It was loose, a little too loose for just spinning a bearing. The rod cap was removed to reveal... Absolutely nothing... the rod bearing was completely gone! I was shocked as I have never seen a bearing completely disappear. So where did it go? We initially found a few shavings in the sledge of the oil pan, yet there was not enough shaving material to make an entire pair of bearings. Upon closer inspection there were little bits and pieces of bearing material sticking to various internal surfaces of the engine and shavings were dripping out of several oil passages; an entire tear down was necessary. Piece by piece the beautiful red Caddy was disassembled and laid out on the work table and the damage was inspected more closely. The crankshaft had taken a beating and needed some major repair as the #3 rod journal was trashed. Similarly the #3 connecting rod was toasted beyond repair and needed to be replaced.

First, this engine was victim of poor quality machine work. Several of the internal clearances and measurements were so far off from the factory specification it is amazing that the engine ran as long as it did. Obviously the shop that did the machine work on this engine is subpar, which unfortunately is way more common than you might think.

Second, the engine rebuilder did not measure anything. This proves the rebuilder was worse than the machinist (hell they could be the same guy). A good rebuilder measures everything just to make sure the machine work is correct, in our case the rebuilder should have caught all the errors in the machine work. However, many rebuilders assume the machine shop “did it right” and assume all aftermarket parts fit the same way the factory ones did. Considering the rarity of our old engines, varying quality & availability of replacement parts, and questionable machine work it is curial that an engine is blueprinted (precisely measured and assembled to factory or performance specs) to ensure that the engine will live a happy long life.

Rod #3... It should have a nice machined smooth surface not jagged metal splinters. Notice the black spots and pits, that is where the metal got too hot and then discolored.

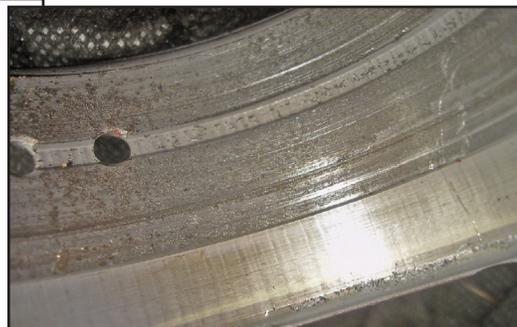
This is a close up of one of the main bearings. Notice the sandpaper like texture of the bearing surface, that is bits of shreaded metal from the destroyed bearing lodged in the surface like shrapnel.

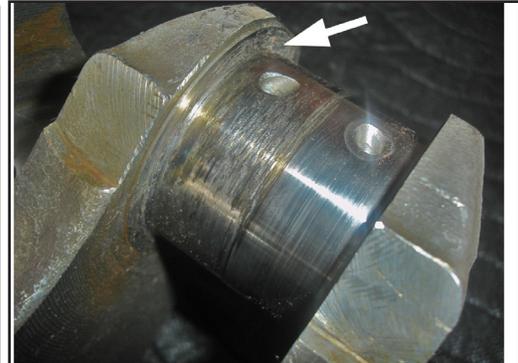
On the left side is journal #3, compare it to #4 on the right side. The damage also includes the thrust surface (arrow). Lucky for us this is a forgedd steel crank so it can be welded up and reground. If this was a cast iron crank we would be SOL.
